SERVICE BULLETIN: JSB 013-1

Date: 8th August 2006

Subject: Jabiru 2200 Engine Rocker Chamber Vent

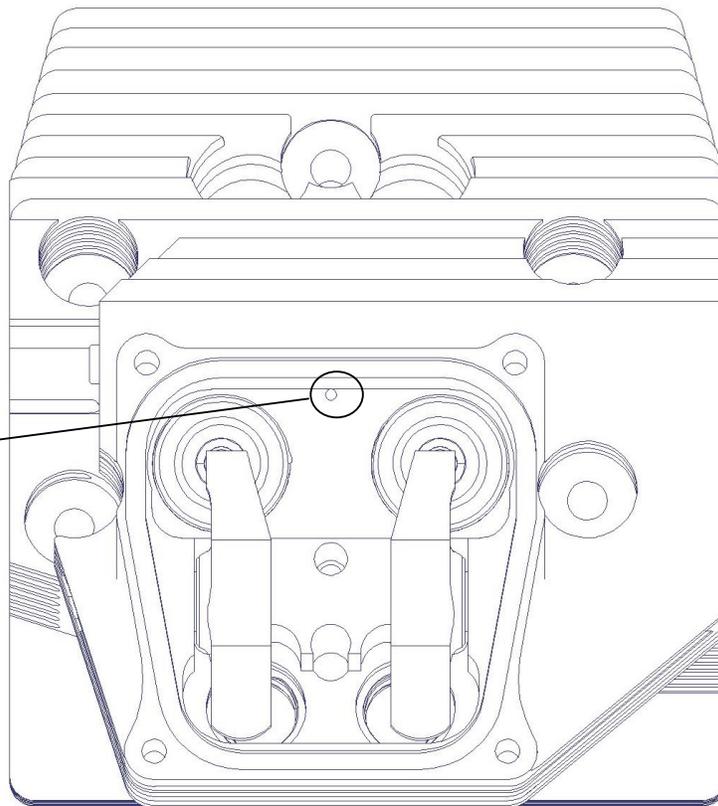
Figure 1. Vent Position – View Looking Parallel to Valves

Vent hole
located midway
between valves
at the top of the
rocker cavity.

- i) With reference to the engine's Instruction & Maintenance Manual, remove the aircraft cowls and engine ram-air ducts.
- ii) Remove the rocker covers from the engine.
- iii) Locate the position shown in Figure 2 below and use a small centre punch to mark the hole position.
- iv) Using a 3/32" drill bit, drill a hole in the head as shown. The hole must angle upwards to encourage oil to flow back into the rocker cavity instead of out into the engine bay. Before drilling, coat the tip of the drill bit with grease to catch the aluminium shavings from the hole. Drill in stages, cleaning and re-greasing the drill every second or two. Ensure that no loose shavings escape into the rocker cavity.
- v) Replace the rocker covers re-assemble the aircraft.

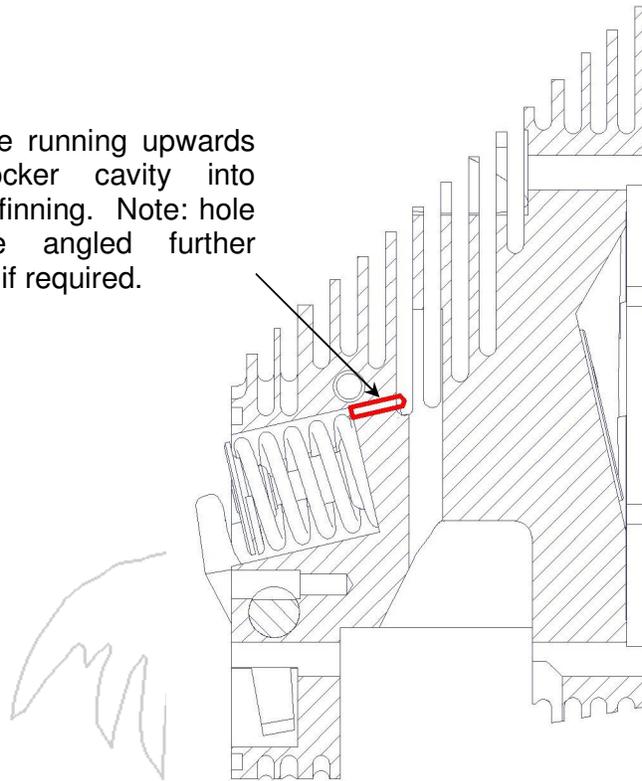
Figure 2. Sectioned View of Head Assembly – Hole Shown.

Vent hole running upwards from rocker cavity into external finning. Note: hole may be angled further upwards if required.
