SERVICE BULLETIN: JSB031

Issue: 3

Subject: Engine Through Bolt Replacement and Upgrade

Affected Models: Jabiru 2200 & 3300 Engines in FLIGHT TRAINING

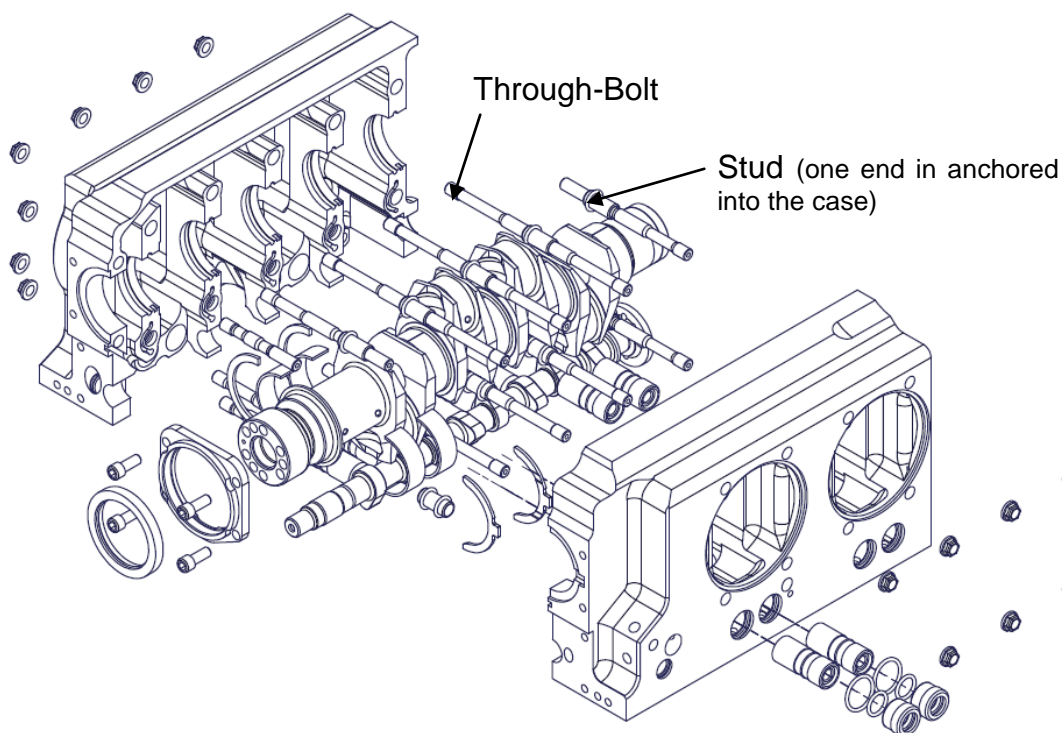
Figure 1 – General Engine Layout

- Jabiru Engines are assembled using a combination of Through-Bolts and Studs – as shown in Figure 1 below. The number of through-bolts varies depending on which engine model is considered but there are always 6 studs (not all with the same part number). The through-bolts and studs hold the cylinders in place and the halves of the crankcases together.

- There have been some cases of these bolts failing in service, leading to engine failure.
- In April 2011 JSB031 Issue 1 was issued. This bulletin detailed then-current inspections and alterations required to correct this potential unsafe condition with the through-bolt hardware of certain Jabiru 2200 and 3300 engines.
