SERVICE BULLETIN: JSB031

Issue: 3

Subject: Engine Through Bolt Replacement and Upgrade

Affected Models: Jabiru 2200 & 3300 Engines in FLIGHT TRAINING

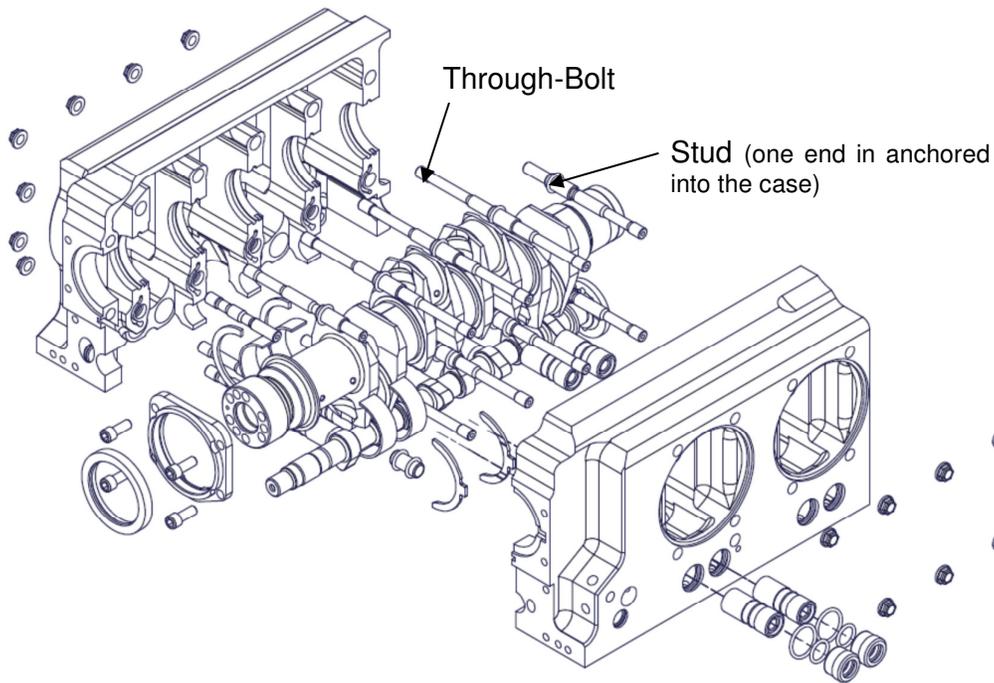
Figure 1 – General Engine Layout

- Jabiru Engines are assembled using a combination of Through-Bolts and Studs – as shown in Figure 1 below. The number of through-bolts varies depending on which engine model is considered but there are always 6 studs (not all with the same part number). The through-bolts and studs hold the cylinders in place and the halves of the crankcases together.

- There have been some cases of these bolts failing in service, leading to engine failure.
- In April 2011 JSB031 Issue 1 was issued. This bulletin detailed then-current inspections and alterations required to correct this potential unsafe condition with the through-bolt hardware of certain Jabiru 2200 and 3300 engines.

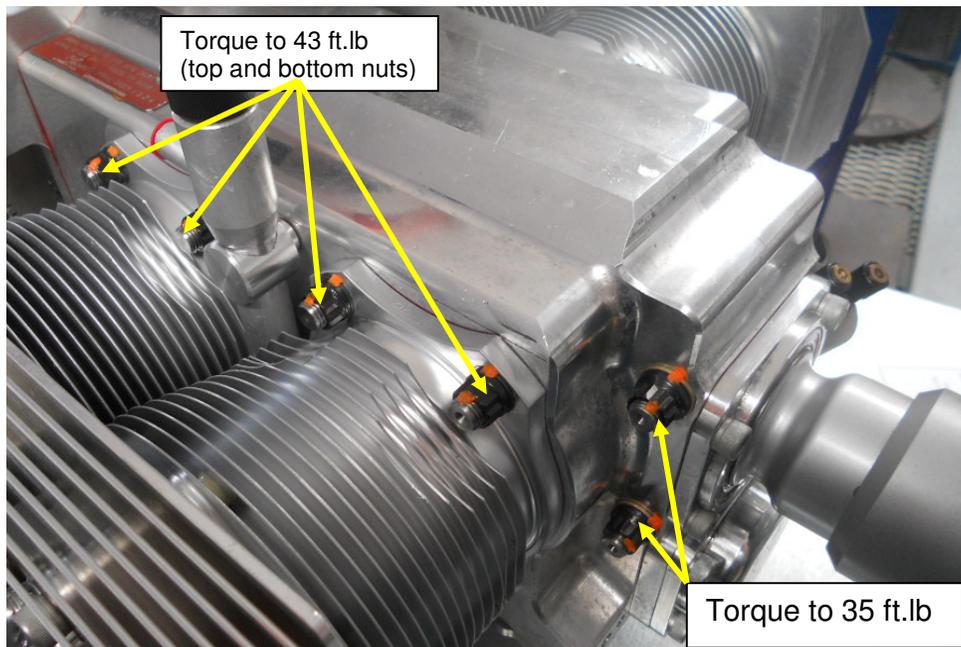
Figure 2: Bolt torques.

- The most important change is the increase in bolt torque. The increased tension better negates joint relaxation which is responsible for movement between the case halves causing the crankcase mating faces to fret and this relieves the through bolt tension, leading to fatigue failure. The change in bolts, nut and thread was made to allow 43ft.lb to be reliably reached without damaging bolt thread and produce a more consistent tension preload for the given torque setting.

At the next 25hrly service, check the torque setting of 12 point nuts with a calibrated torque wrench. Prior to checking the torque, conduct crankshaft friction test as per section 6.2. If the torque was found to be less than 43 ft/lbs they should be retorqued to 43 ft lbs, if they are less than 43 ft lb. Reapply torque seal. Please see Figure 2.

When re torquing the through bolts, to ensure that the torque value is accurate, the bolts have to be loosened by 1/4 of a turn before torqueing up again. There must not be any locking compound on these bolts/nuts, if there is any indication of locking compound the nuts must be removed and the threads cleaned, then re-installed as per the section below. Loctite prevents the correct bolt tension from being achieved and the torque being checked.

Only loosen and change the nuts/washers on one bolt at a time. Then torque to 43 ft lb before undoing the next bolt. This will avoid losing too much clamping force of the case. If a locking compound was used on the bolt/nuts, threads must be cleaned before nuts are refitted. Once all bolts are done check the torques and apply torque seal. Please see Figure 2.
