## **SERVICE BULLETIN: JSB 040-2**

**Subject: Jabiru Mechanical Fuel Pump**

**Affected Models: All engines up to S/No. 22A3811 & 33A2768.**

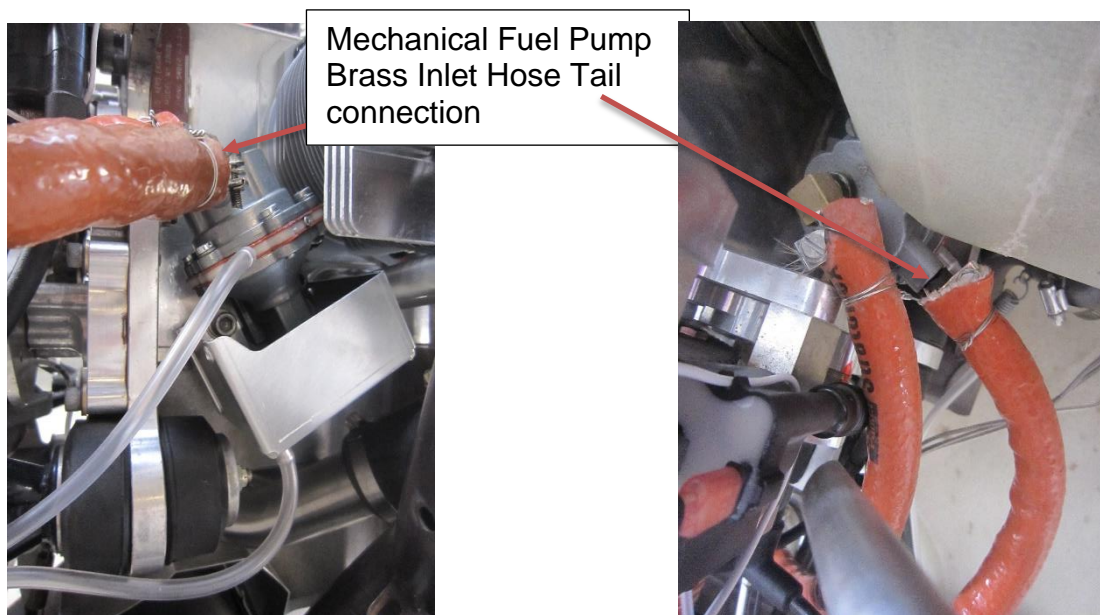
**Figure 1 Mechanical Fuel Pump Brass Inlet Hose Tail location**

- 1) Remove the aircraft cowl.
- 2) Locate the mechanical fuel pump (the position on engine is shown in Figure 1).
- 3) Inspect the brass fuel inlet hose tail to fuel pump body connection for security of attachment.

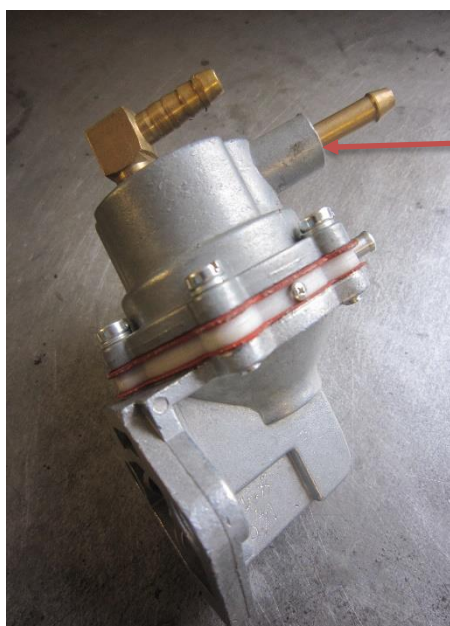
**Figure 2 Mechanical Fuel Pump**

Inspect the security of the fuel brass inlet hose tail in the body of the fuel pump

If it is found that the hose tail is loose in the body of the fuel pump, this condition must be corrected **before further flight**. Contact Jabiru Aircraft if this situation is encountered and complete a Continued Operating Safety Reporting Form that can be found at the following web address: [http://jabiru.net.au/images/Owner\\_Operator\\_Responsibilities.pdf](http://jabiru.net.au/images/Owner_Operator_Responsibilities.pdf)

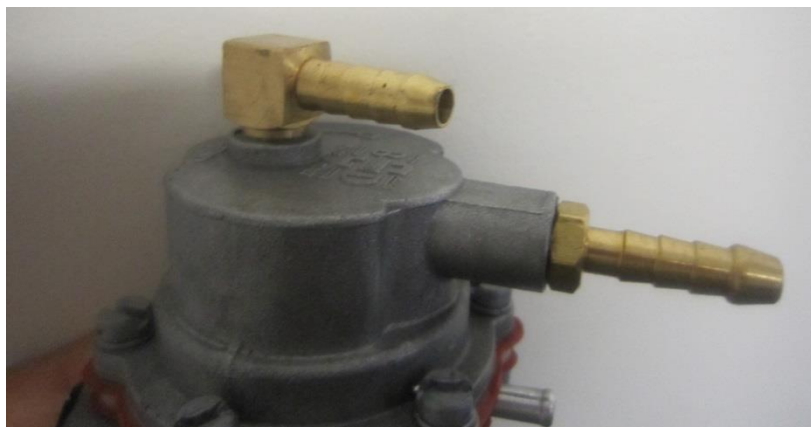
**Figure 3: Pump with both fittings screwed in. (No further inspection required)**
