Jabiru Service Letter: 2200 Engine Distributor & Rotor			JABIRU AIRCRAFT PTY LTD		
			P.O. Box 5792 Bundaberg West Queensland, Australia.	Phone:+61 7 4155 1778 Fax:+61 7 4155 2669 Web: www.jabiru.net.au Email: info@jabiru.net.au	
JSL015-1	Release Date: 15th Dec 2014	Effective Date: 5th Jan 2015	Affected Models: See Applicability	S/No. Range: See Applicability	Page 2 of 5

LSA Service Notification: JSN 015

Subject: 2200 Engine Distributor & Rotor

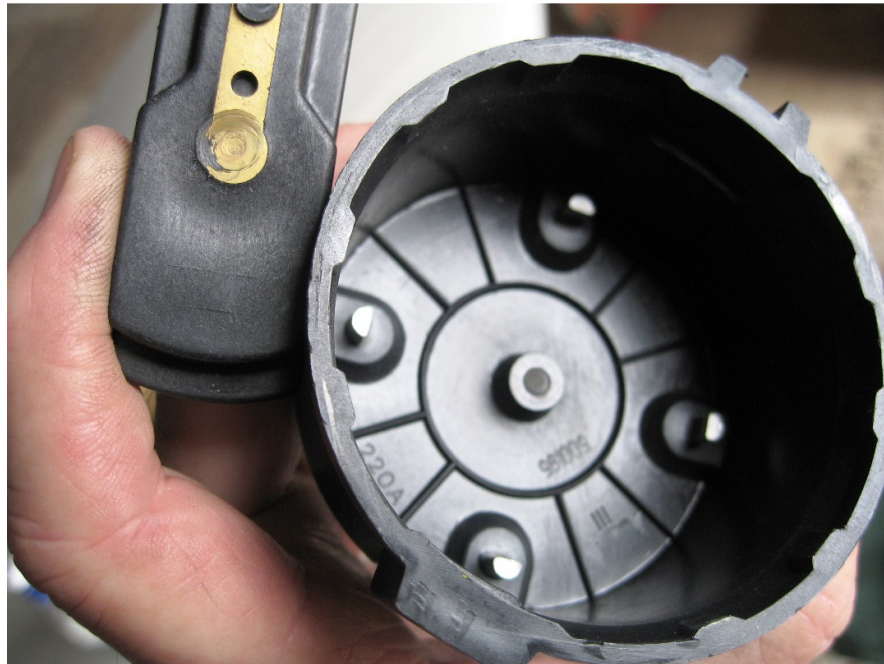
- In July 2014 Jabiru Aircraft released a notification to owners of certain 2200 engines regarding a potential issue affecting their ignition systems.
- The issue can occur when the housing for the spring-loaded central carbon brush rubs against the rotor as it turns. Over time in service the friction in this area can “weld” the rotor to the cap and in some cases has led to a failure of the rotor and then of the ignition.

Figure 1 – Damaged Distributor and Rotor

- Where the original OEM parts or parts supplied in the time frame noted on Page 1 are fitted to engines within the applicability limits: Jabiru Aircraft recommend that both distributor caps are removed and both the cap and rotor inspected. Damaged parts are to be replaced in accordance with the details given in the Jabiru Engine Maintenance Manual – Document JEM0002 (latest approved issue).
- Where the parts have already been replaced no inspections are required.

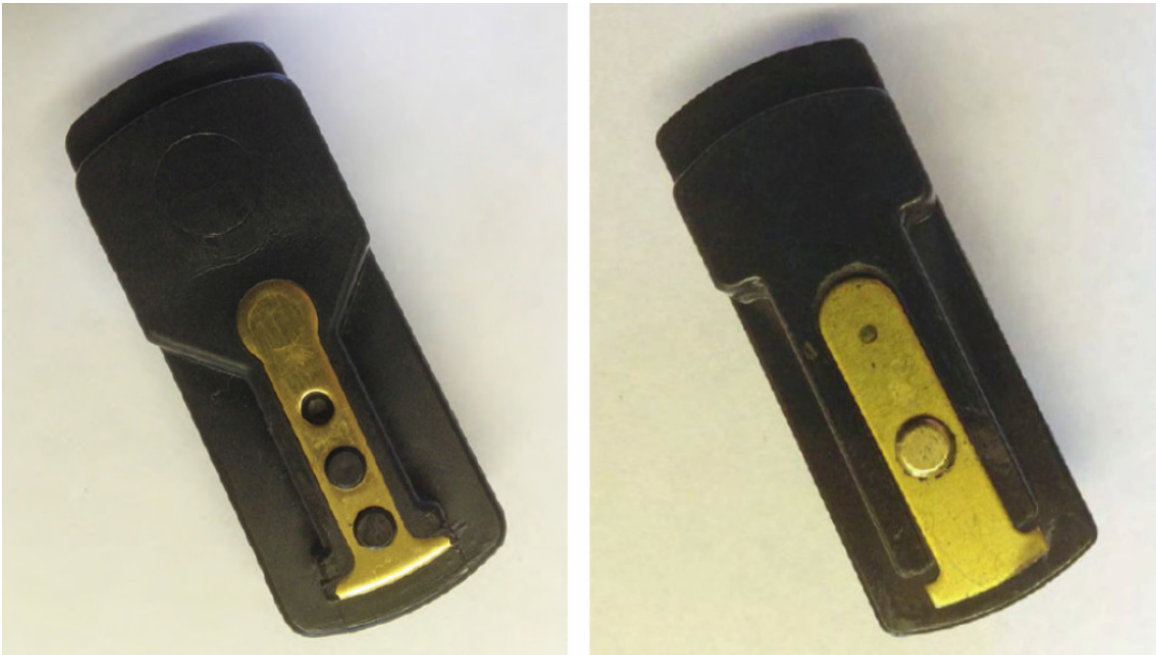
Figure 2 – Bosch Rotor (on left) and Pattern Part (right)
