| Early Jabiru 6 Cylinder Engine Muffler – Tractor Installations | | | | |

**SERVICE BULLETIN:** JSB 005-2

**Subject:** Early Jabiru 6 Cylinder Engine Muffler

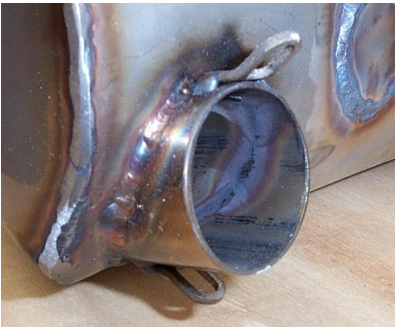
All Jabiru 6 cylinder engines fitted with a Jabiru Muffler **Single Inlet P/No.4683083, 4795003 & 4A061A0D.**

**Figure 1: Bulletin applies to these inlets.**

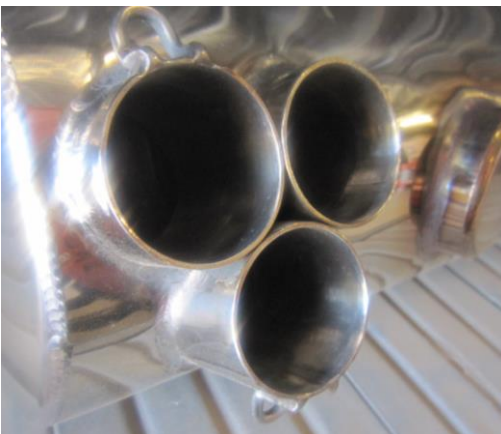
**Figure 2: This bulletin does not apply to mufflers with these inlets.**

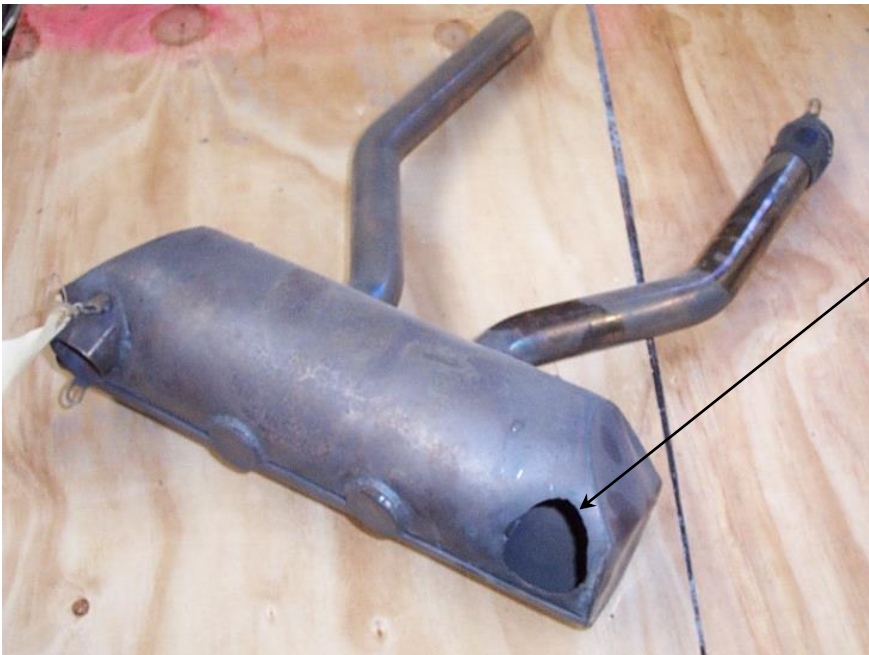
**Figure 3. Typical Muffler Failure.**

Some mufflers fitted to Jabiru 6 cylinder engines in tractor configured aircraft failed in 2004 due to the inlet socket cracking and breaking free of the muffler body. When a failure of this type occurs the muffler body falls away from the exhaust manifold and drops down onto the lower cowl, but it does not fall away from the aircraft. The failures were traced to

mufflers which had had their inlet pipes welded in using a MIG welder in place of the TIG welder that is normally used. Refer to the figures below for pictures of a MIG-welded stub and a TIG-welded part.

Stub broken away from muffler body, including the spring loop.

Visually inspect the muffler as soon as possible. Check for cracks in the areas indicated and determine if the welds are MIG or TIG type (if the owner is in doubt, a qualified welder will be able to tell which process was used). If any cracks are found they should be repaired using a TIG welder before further flight. If no cracking is found and the welds are TIG type, the aircraft can be continued to be flown as normal, with normal scheduled inspections of the exhaust system every 50 hours as described in the maintenance manual.

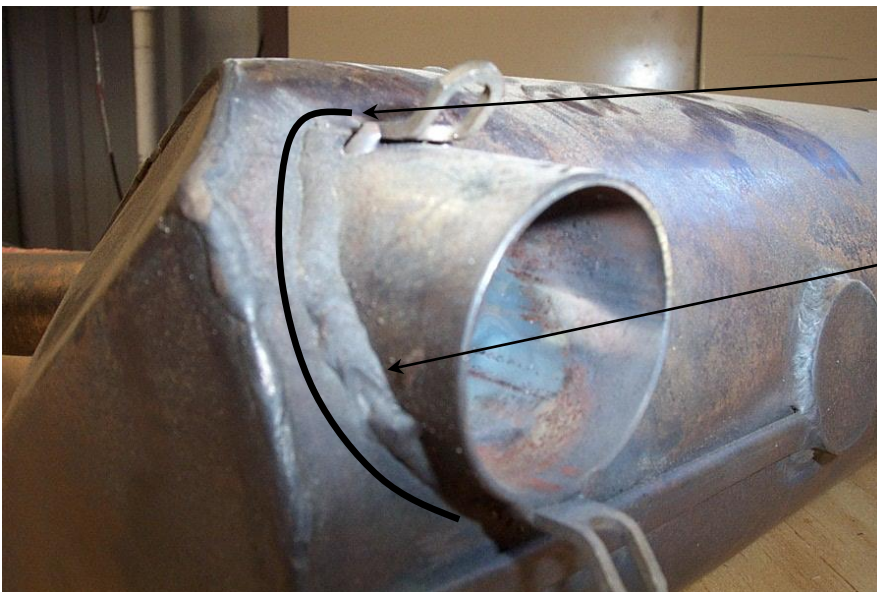
**Figure 4. Example MIG-Welded Inlet Stub**

Cracking occurs around the outside of the weld bead, in the body of the muffler.

MIG Weld. Note that weld bead is convex, with "beach marks" spaced further apart. Ref Figure below.

If no cracking is found but the welds are MIG type, the aircraft may continue to be flown, but the muffler should be inspected for cracks at 5 hour intervals until the muffler is repaired. To repair MIG welded mufflers, the MIG bead should be ground back to allow room for a TIG weld bead around the perimeter of the existing MIG weld. The TIG welding should then be carried out by a qualified TIG welder.

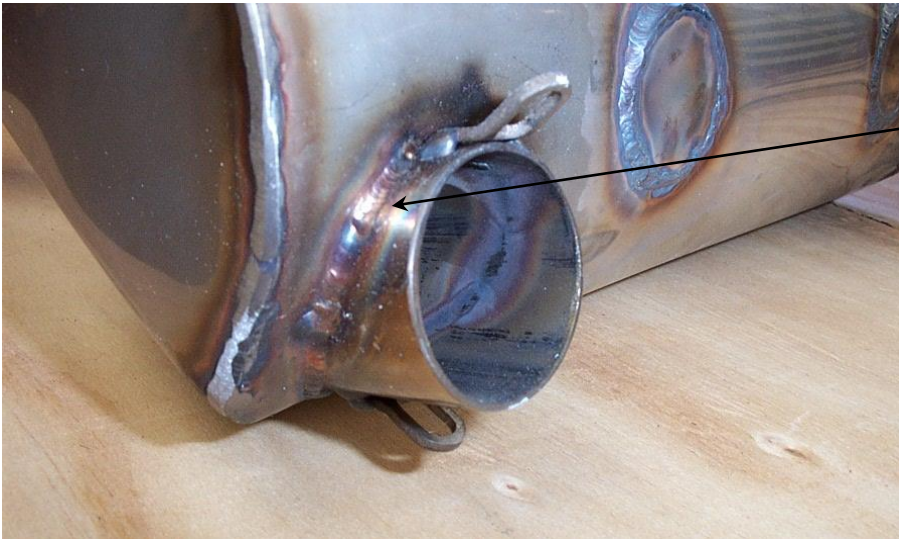
Figure 5. Example TIG-Welded Inlet Stub

TIG Weld. Note that weld bead is smaller, concave, with “beach marks” spaced more closely. Ref Figure below.

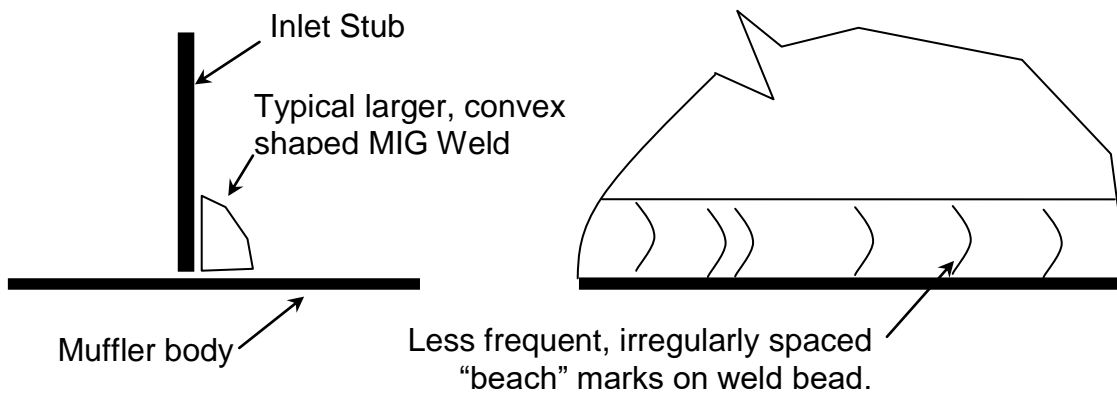
Figure 6. Typical Features of MIG and TIG Welds

**Typical MIG Weld Features**

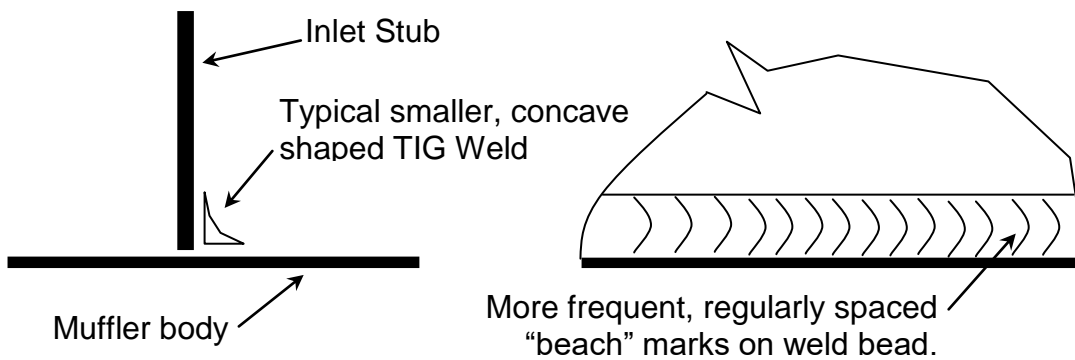
**Typical TIG Weld Features**
