SERVICE BULLETIN: JSB 038-1

Release Date: 22nd June 2015

Subject: Jabiru Composite Propeller

Affected Models: All Jabiru Composite Propellers.

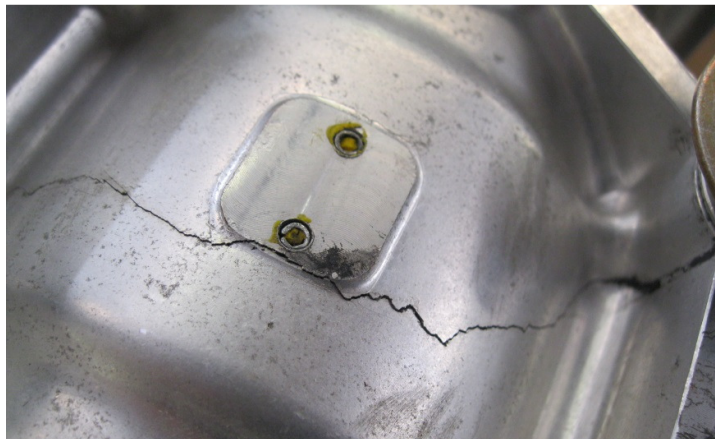
- One only instance has occurred where a large crack was found in the rear hub. The crack was identified during an inspection after the pilot noticed unusual vibration. The propeller had completed approximately 400hrs TTIS.
- Inspection and testing of the parts in question have been carried out and several items identified which contributed to the failure. In isolation the effect of each is minor and does not cause an unsafe condition.
- In the rare case where all of these items are present in one assembly they may combine to increase stress in the hub beyond acceptable design levels, ultimately leading to the damage seen.

Figure 1: The Crack Detailed in Section 2.

- **Option A – Recurring Inspection.** Carry out an inspection of the propeller in accordance with Section 5.1 within the timeframe given in Section 4. This inspection must then be repeated at the intervals specified until the propeller can be returned to have the Option A, one-off inspection carried out.
- **Option B – One-Off Inspection.** Contact Jabiru Aircraft (Australia) or local representative and schedule the propeller to return to an authorised organisation for a one-off inspection within the time limits of Section 4. Only Jabiru Aircraft (Australia), Jabiru USA, Jabiru South Africa and approved¹ organisations (in other countries) will be authorised to carry out rectification work to the propellers.

- Remove spinner.
- Loosen evenly then remove the 4 centre AN5 nuts that secure the propeller.
- Remove the front spinner mounting plate and washers. Take note of the order and location of the washers.
- Remove the propeller from the engine, taking note of the installation orientation on the propeller flange.
- Visually inspect the hub for visible cracks. See Figure 1.
- If cracking is found, mark the part as UNSERVICABLE and contact Jabiru Aircraft (Australia) for guidance on repair/replacement.
- If no cracking is found, reinstall propeller as per manual JPM0001 Section 4.7.5 "Procedure – Propeller Installation".
