SERVICE LETTER: JSL019

Subject: Rudder Cable End Inspection.

Affected Models: All Jabiru Airframes.

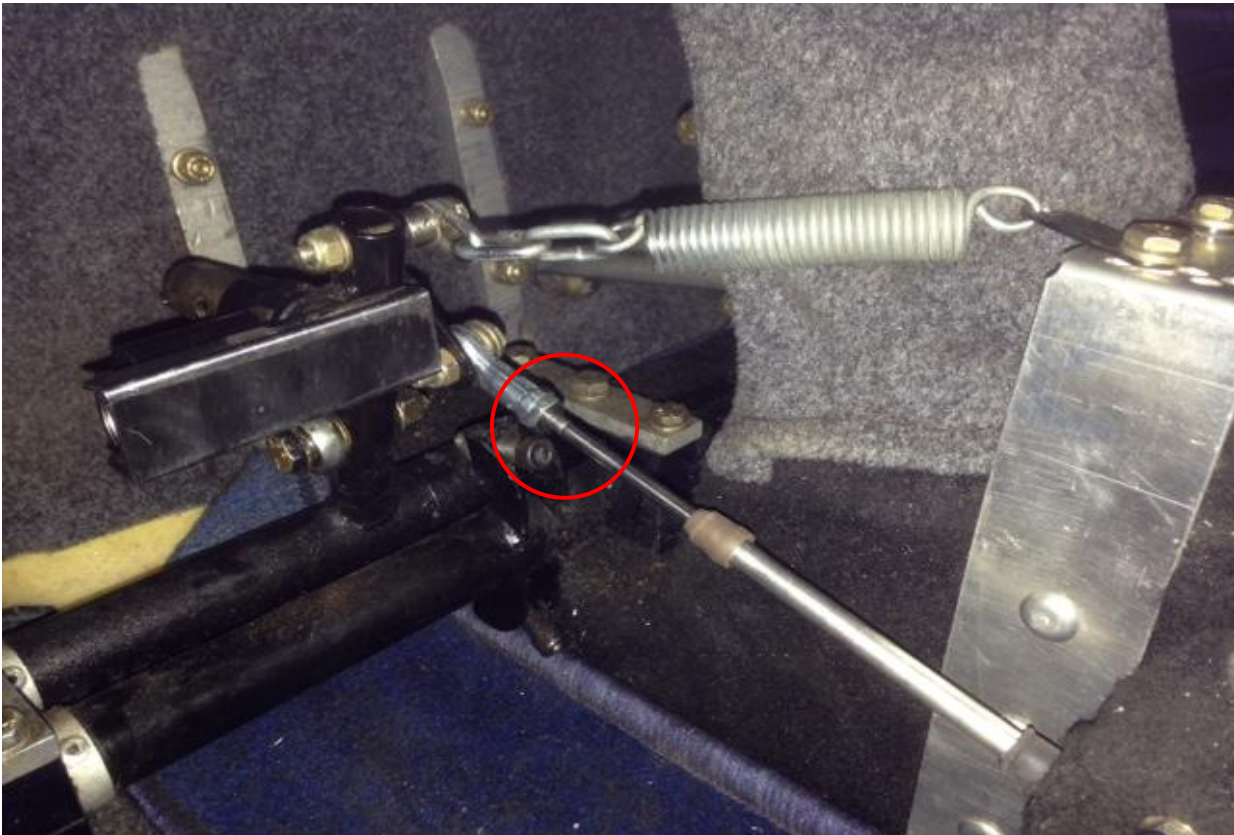
- A single incident involving the precautionary landing of a Jabiru aircraft has highlighted a condition which can potentially lead to an in-flight loss of rudder control.
- On inspection, by the operator, it was found that the rudder cable had broken.
- Jabiru inspected the parts and have found that the cable end had been bent before it failed.
- This service letter has been prepared to inform operators and maintainers of Jabiru Aircraft of this condition.

Figure 1 – Location where cable broke.

- Cable end condition need to be checked during daily inspection, as with other external cable ends.
- The Jabiru Airframe Technical Manual (JTM001) contains requirements for the maintenance of control cables and rod ends. **Cables with bent shaft ends MUST BE REPLACED before any further flight. Bent shaft ends cause bending loads through the threaded section which will cause the cable end shaft to fail.**
- Always refer to the most recent revision of these documents.
- Rudder pedal linkages and cables ends are inspected every 100hrs.
- **Responsibilities of LSA owners to report incidents.**
http://jabiru.net.au/images/Owner_Operator_Responsibilities.pdf

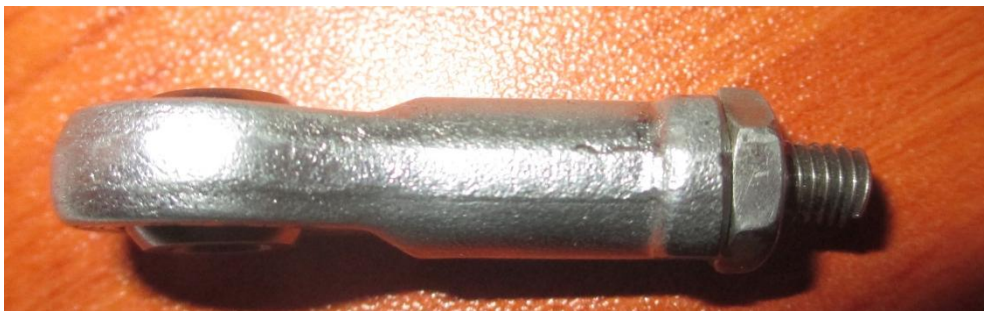
Figure 2: Rod end with broken end of cable.

- All Jabiru Aircraft use a push pull type rudder cable. The end of the cable is fitted with a rod end, for attachment to rudder pedals. **The factory installation has proven to be suitably robust in service.** (1 confirmed instance for over 8,000 cables in service)
- The only likely cause of the cable being bent, in this instance, is force applied by a pilot's foot. The bend was in the horizontal plane. Investigation revealed that a large amount of force was required at an awkward angle.
- The rudder cable end is stainless steel so once bent only a small number of push pull cycles are needed to cause it to break.
