SENENICH PROPELLER CO., INC.

SERVICE BULLETIN SB 10-07-21

SUBJECT: Inspection of blade shanks for possible cracks

AFFECTED PROPELLER MODELS: All R64Z, L62P, and R62H composite propeller blades used on Jabiru series engines

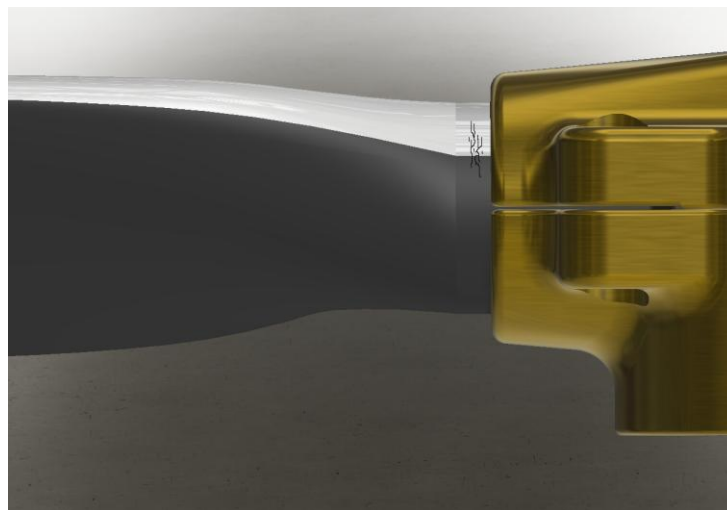
REASON: Sensenich has received reports of paint cracks on the shanks of Jabiru composite propeller blades. Cracks have been found on the leading and trailing edge portions of the shank, where the blade shank exits the hub and transitions into the blade airfoil. **See Figure 1. and Figure 2.**

Cracks examined to date have not progressed deeper than the outer composite ply, but the crack location warrants regular preflight inspection to detect possible crack formation and propagation.

Figure 1. Side View of Jabiru propeller blade with shank paint cracks

COMPLIANCE: -*Inspect blade shanks prior to each flight.* Run your fingers around the root where the blade exits the metal hub, and check for loose fibers, cracks, or rough areas.
-Notify Sensenich of any occurrences and return for evaluation.

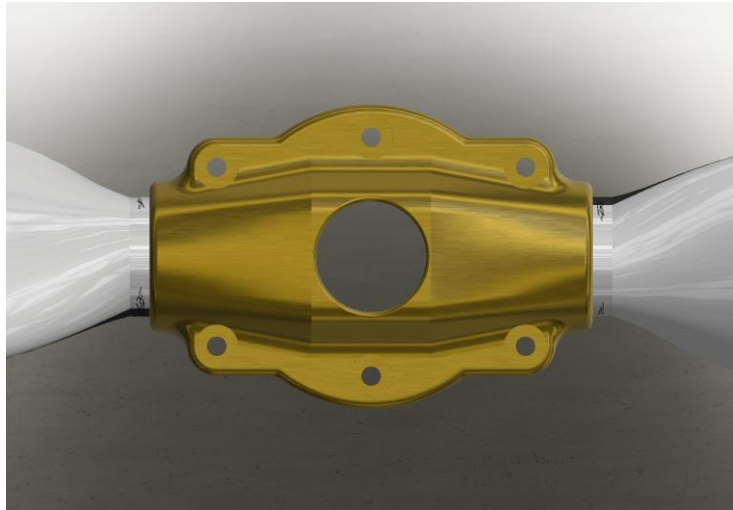
Figure 2. Top View of Jabiru propeller with shank paint cracks
