SERVICE BULLETIN: JSB 040-2

Release Date: 19th December 2017

Subject: Jabiru Mechanical Fuel Pump

Affected Models: All engines up to S/No. 22A3811 & 33A2768.

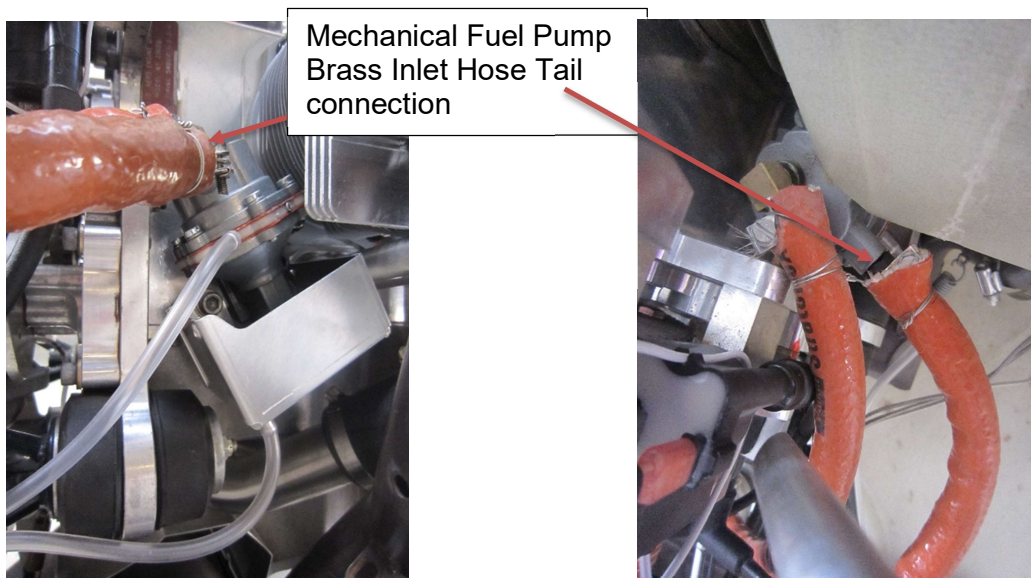
Figure 1 Mechanical Fuel Pump Brass Inlet Hose Tail location

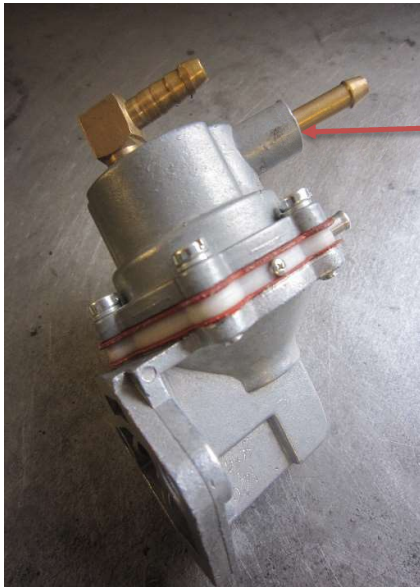
Figure 2 Mechanical Fuel Pump

- During routine maintenance a brass intake hose tail connection on a Jabiru mechanical fuel pump body was found to be loose.
- This service letter acts as a precautionary service message to inform maintainers and operators of this potential condition and prescribes an inspection to check that the brass intake hose tail connection is securely fitted to the body of the fuel pump.
- This service bulletin has been brought into effect as a means of assessing the prevalence of this condition in the Jabiru engine fleet.
- **Since the issue was discovered all new mechanical fuel pumps produced by Jabiru have screwed in brass hosetails to avoid this issue.**

Inspect the security of the fuel brass inlet hose tail in the body of the fuel pump

If it is found that the hose tail is loose in the body of the fuel pump, this condition must be corrected **before further flight**. Contact Jabiru Aircraft if this situation is encountered and complete a Continued Operating Safety Reporting Form that can be found at the following web address: <https://jabiru.net.au/wp-content/uploads/2018/05/COSM-3.pdf>

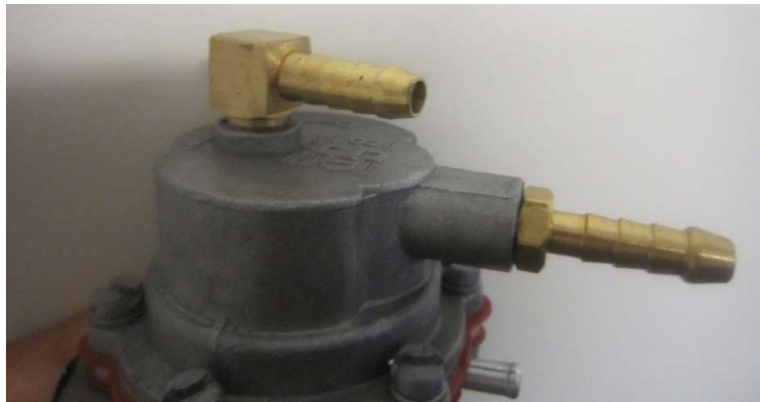
Figure 3: Pump with both fittings screwed in. (No further inspection required)
