SERVICE LETTER: JSL024-1

Subject: Cylinder barrel threads

Affected Variants: Jabiru Engines Gen 3, 2 and 1

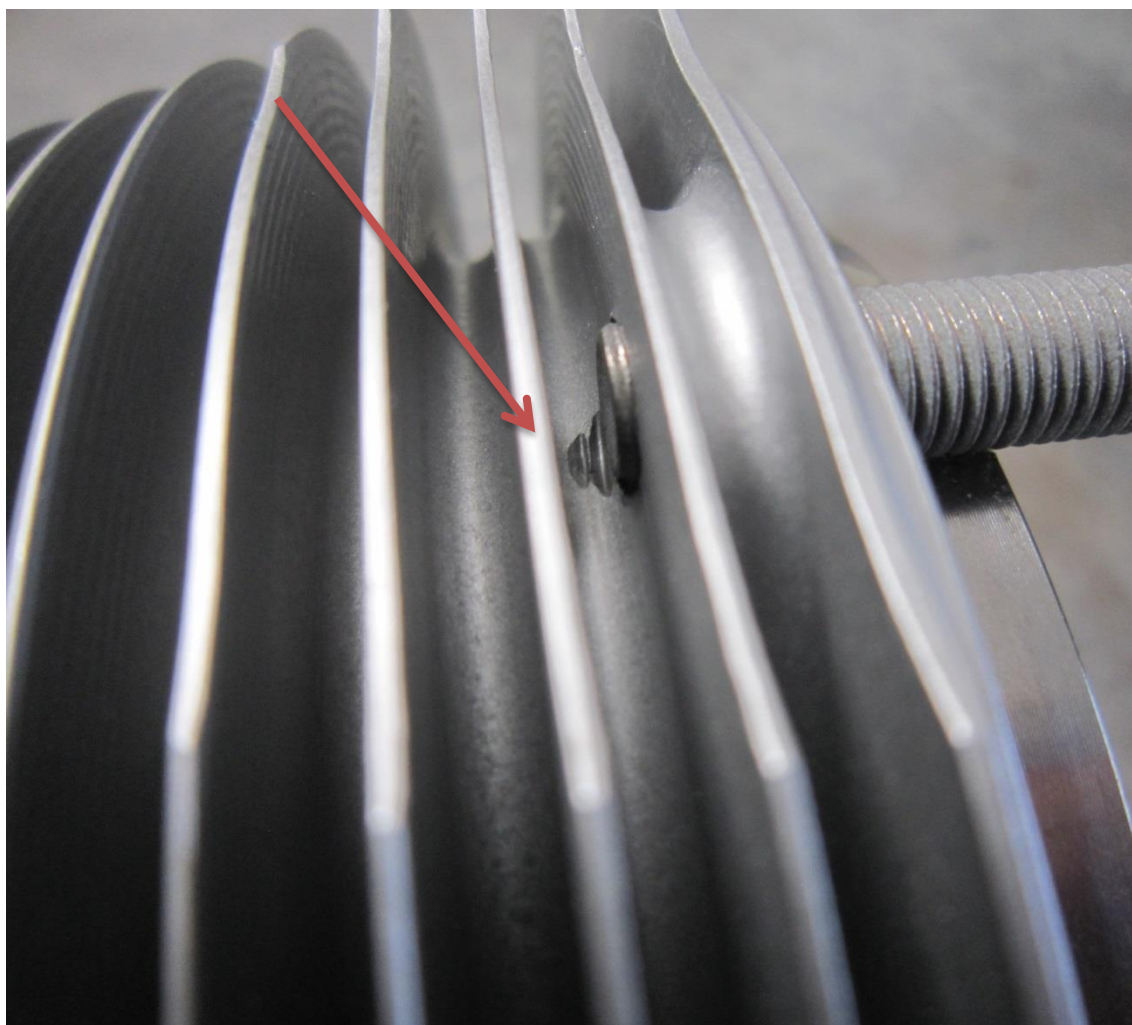
bolts may tighten against the end of the thread rather than applying clamping force to the cylinder head. This is most prevalent on the exhaust port side of the cylinder-head. Without proper clamping the seal between the cylinder-head and cylinder-barrel may be compromised, causing leakage of combustion gases.

Figure 1: Bolt against end of usable thread, any further tightening will damage bolt thread.

- The first step is to observe how far the end of each attachment-bolt protrudes out of the threads in the cylinder-barrel (see Figure 1 above).
- If any more than that shown in the above figure (i.e. about ½ to 1 thread), the bolt should be backed off ½ turn or removed and the threads on the end of the bolt inspected for damage (squashing or galling).

- Put a flat washer under the head of the attachment bolt to reduce the reach of the bolt.
- On several of the attachment bolts, there exists little lateral space so a relatively small diameter washer will be required.
- In all cases aircraft grade washers must be used such as half thickness and full thickness AN5 plain washers. Note that due to lateral clearance issues some modification (e.g. grinding the edges) of these washers may be required to allow them to fit correctly.
- After reinstallation of the attachment bolt with the spacing washer(s), make sure that the attachment bolt still comes at least flush through the threads in the cylinder-barrel. If the end threads of the attachment bolt have been damaged by binding or galling then it must be replaced with a new one.

- Grind the end of the bolt so that the excess thread that protrudes past the threads on the barrel is entirely removed. Full thread engagement in the barrel is still required.
- Grinding the thread away, so the tip of the attachment bolt is tapered may also be sufficient to prevent the bolt bottoming and the thread binding.
- Do not overheat the bolt during any grinding processes conducted.
