Jabiru Service Letter: Valve Spring Washer Wear			JABIRU AIRCRAFT PTY LTD P.O. Box 5792 Bundaberg West Queensland, Australia. Phone:+61 7 4155 1778 Fax:+61 7 4155 2669 Email: info@jabiru.net.au		
JSL 008-2	Release Date: 19th December 2017	Effective Date: 19th December 2017	Affected Models: See Sheet 1	S/No. Range: See Sheet 1	Page 1 of 5

SERVICE LETTER: JSL 008-2

Subject: Valve Spring Washer Adverse Wear

Affected Engines: All Jabiru Engines up to Serial No. 22A3713, 22B317 & 33A2603 unless fitted with hardened valve spring washers during servicing.

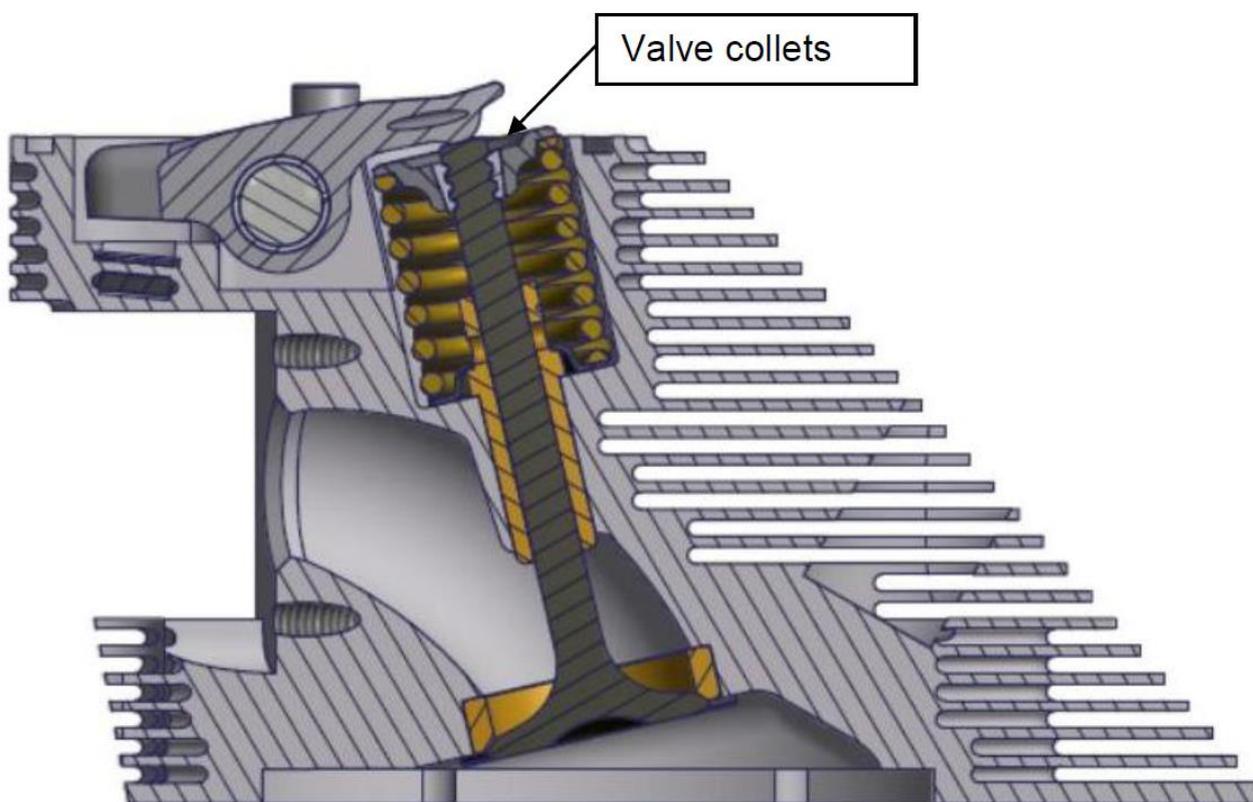
Figure 1: Valve & Spring Cross Section

- Jabiru Engines use a conventional arrangement of washers and collets to retain the valve spring assemblies (Figure 1).
- By design the valves are normally free to rotate within the valve collets. The valve actuation mechanism applies a small rotational force to the valve, rotating it to maintain valve sealing.
- Two incidents, one year apart, have been reported to Jabiru Aircraft: in each a valve jammed in the collet, causing the top spring washer to rotate with the valve and wear against the valve spring, eventually causing a failure of the washer and engine stoppage.
- In both cases the parts in question had completed 600 – 800 hours in service.
- In both cases the engines were operated in dusty conditions and dirt contamination was found within the carburettor and intake plenum. It is likely that dirt contamination caused the valve to jam in its collets.

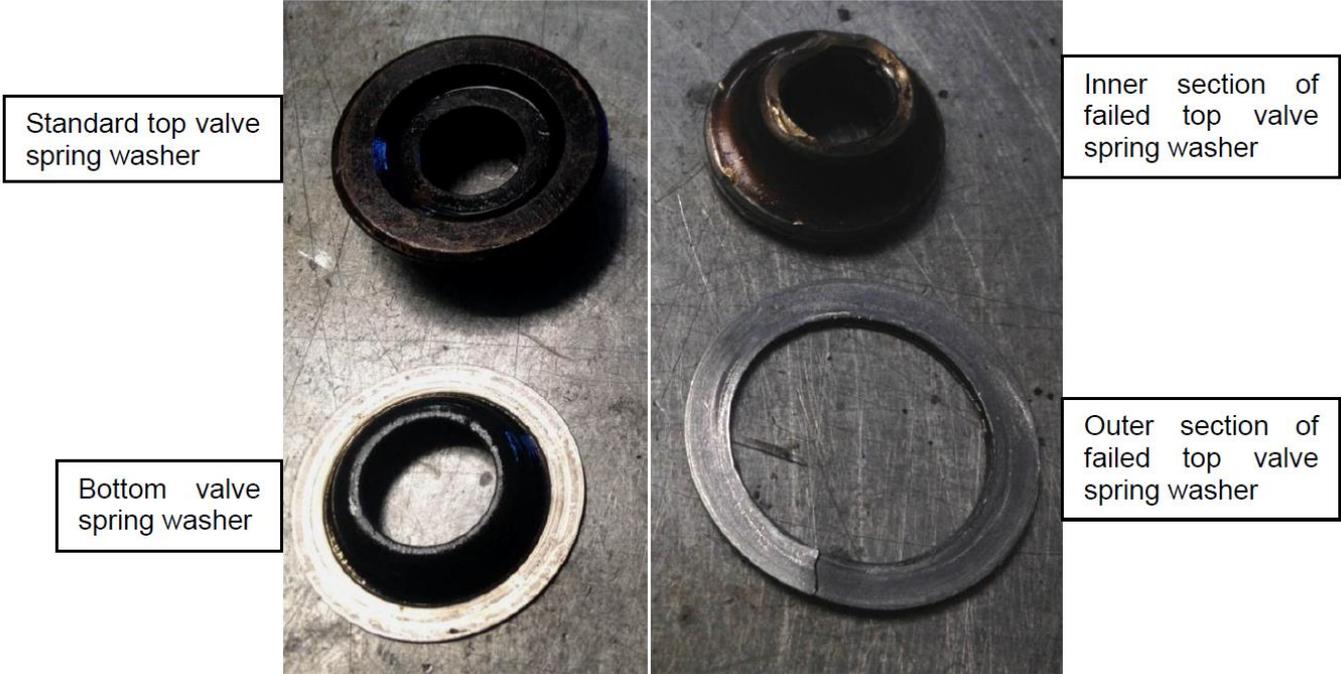
Figure 2: Valve Spring Washers

- Jabiru Aircraft are releasing this document to alert owners and maintainers to the potential issue. The next revision of Jabiru engine service documentation will also incorporate the inspections detailed herein.
- This Service Letter is equivalent to a Manufacturer's Special Airworthiness Information Bulletin (SAIB) for engines operating in Light Sport Aircraft categories.
- This letter has not been mandated (as an AD or similar) by any National Airworthiness Authority at the time of writing.
- **Since the initial issue of this Service Letter, Jabiru has released hardened top spring washers. These are incorporated in all new engines and spare parts.**

- Thoroughly inspect all valve washers and replace any which show signs of wear.
- Trial fit all valves to their collets and assess the fit before assembly; the valve should be free to rotate within the collet. While some friction is normal, binding or jamming is not acceptable. If friction is judged excessive the over-hauler should try the valve in other collets and, if necessary, source replacement parts.

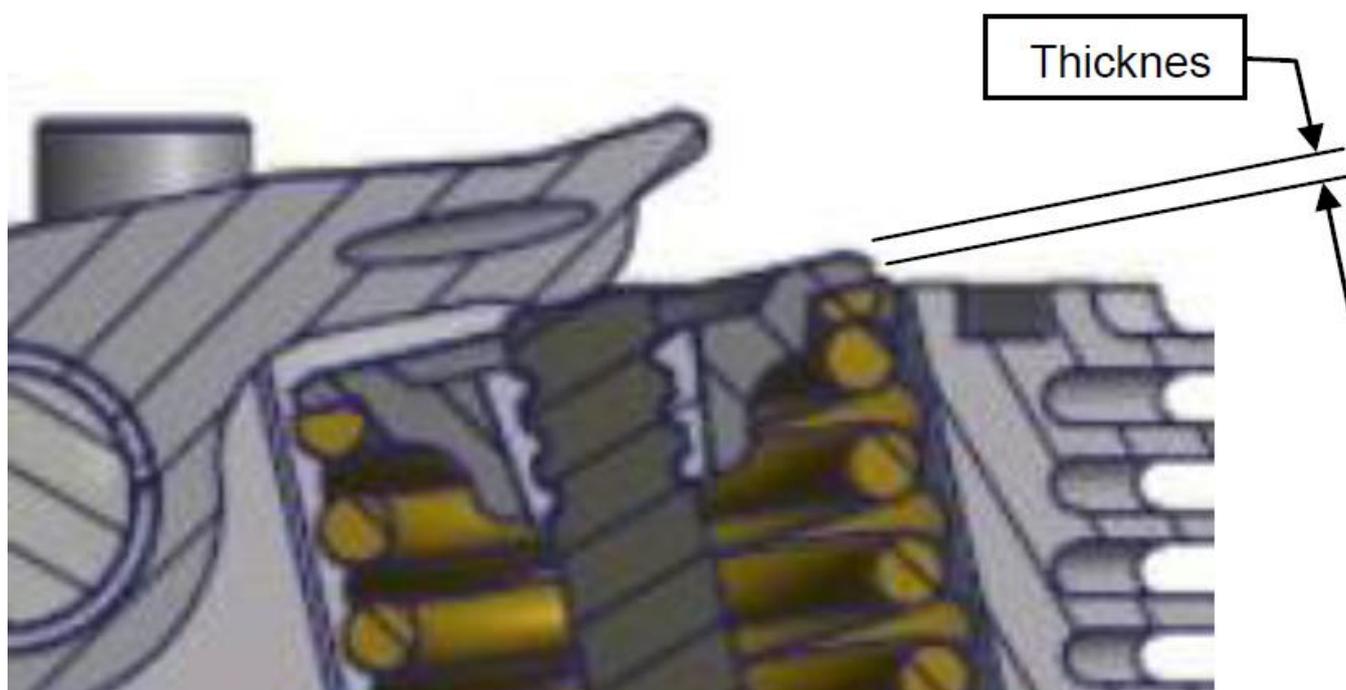
Figure 4: Washer Thickness Measurement

- Visually inspect the top spring washer. A washer which is being worn may show burrs on the outer edge and the reduced thickness may be evident.
- The thickness of the top valve spring washer may be measured (Figure 4). Older washers should measure 1.5mm, newer parts 2.0mm (2mm thickness was introduced from S/No. 332486, 22A3514 and 22B263 and spare parts from June 2011). Any measurement below 1.3mm must be investigated; failure typically occurs at around 1.0mm.
- Thickness of washer can be measured, without head disassembly, by using a depth vernier. See JSL014 Cylinder Head Inspections for additional information.
