<p align="center">Jabiru Service Letter: Cylinder Head Inspection</p>			<p align="center">JABIRU AIRCRAFT PTY LTD</p>		
			<p>P.O. Box 5186 Bundaberg West Queensland, Australia.</p>	<p>Phone:+61 7 4155 1778 Fax:+61 7 4155 2669 Web: www.jabiru.net.au Email: info@jabiru.net.au</p>	
<p>JSL 014-2</p>	<p>Release Date: 5th August 2015</p>	<p>Effective Date: 12th August 2015</p>	<p>Affected Models: See Applicability</p>	<p>S/No. Range: See Applicability</p>	<p>Page 1 of 14</p>

SERVICE LETTER: **JSL 014-2**

Subject: **Jabiru Cylinder Head Inspection**

Affected Models: **All Jabiru Engines**

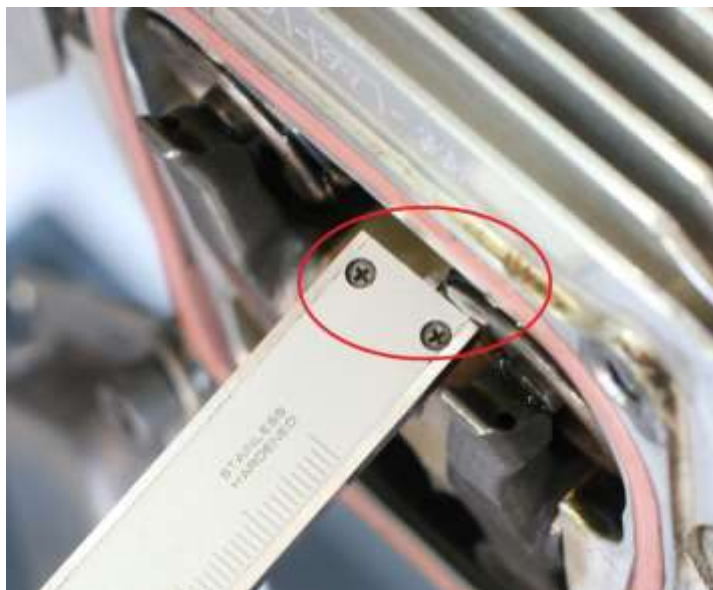
- Remove the rocker covers from all heads (see Head Bolt Tension JEM0002 Jabiru Maintenance Manual).
- Set depth vernier at 1.5mm and compare with the top spring washer and look for any signs indicating wear. If signs are present, proceed with **5.1 Cylinder Head Removal and Inspection**. Also refer to JSL-008 21st Dec 2012.

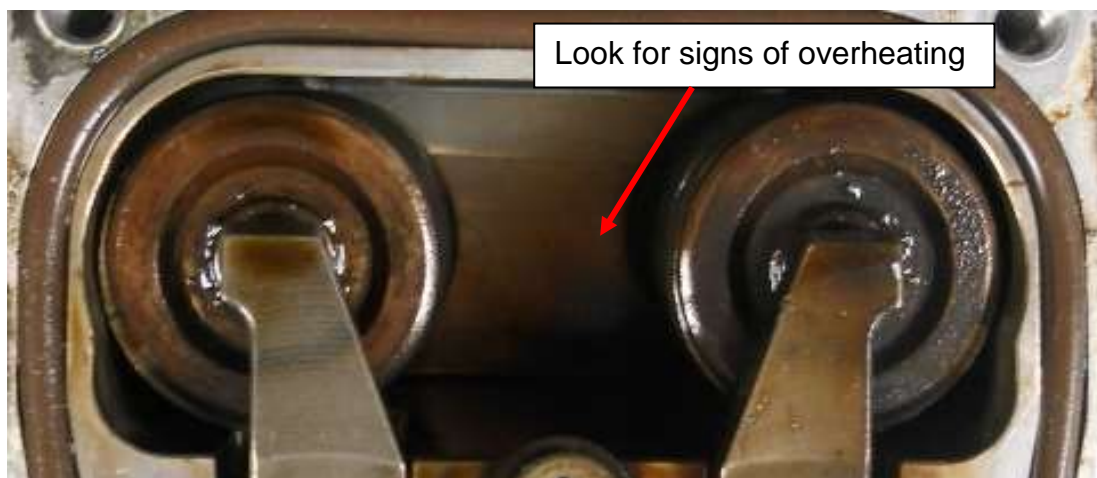
- Look for signs of overheating. If signs are present, proceed with **5.1 Cylinder Head Removal and Inspection**.
