SERVICE LETTER: JSL 014-5

Date: 19th December 2017

Subject: Jabiru Cylinder Head Inspection

Affected Models: All Jabiru Engines up to S/N 22A3811 & 33A2768 (excludes Gen 4 engines)

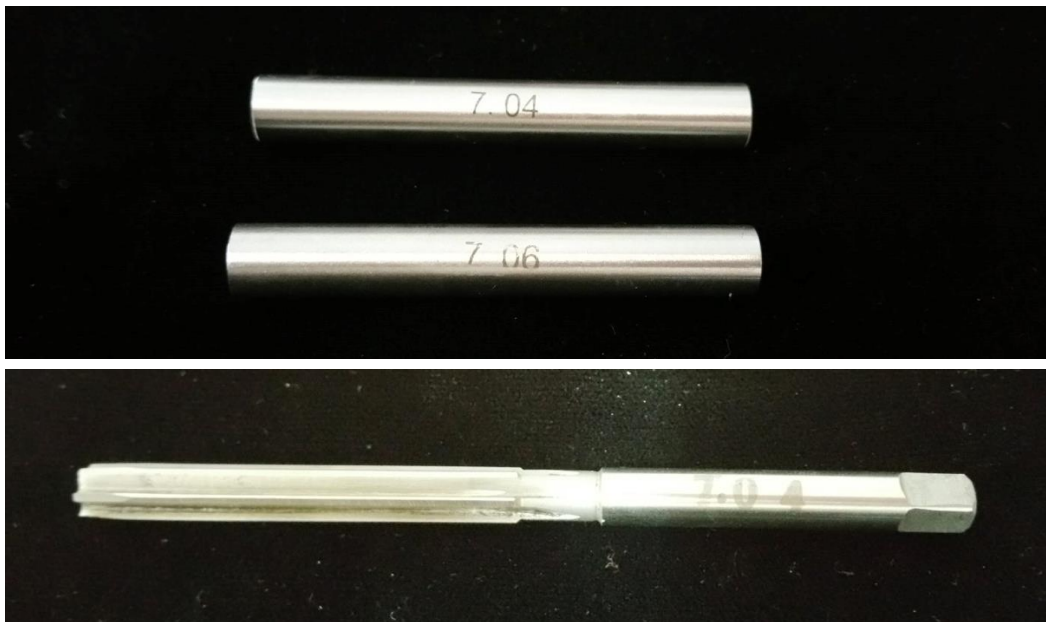
- Inspect the valve guides. Check there is not excessive carbon build-up. Check the diameter of the guide is within the limits specified in the build tolerances table in JEM0001, using a 'Go-No Go' tool. Ream out valve guides if required to meet the tolerances specified in the Engine Overhaul Manual (JEM0001). Go-No go gauges and the hand ream can be purchased as a kit from Jabiru Aircraft.

Figure 1: Valve guide Go-No go gauges and hand ream (available as a kit from Jabiru Aircraft)

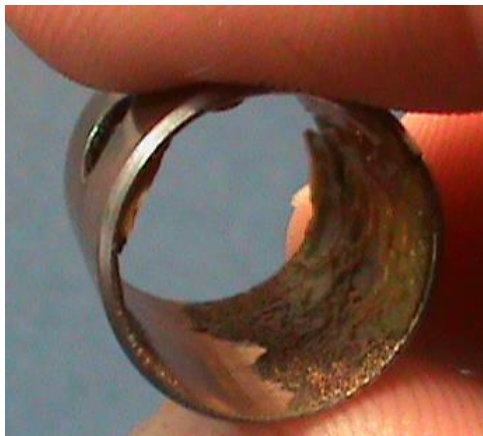
- Inspect rockers. In particular inspect the condition of the rocker bushes, check the bush for melting or other deterioration. Insert the rocker shaft and check that the rocker moves freely (but not loosely) on the shaft. Replace rocker bushes with new parts if required. In the photograph below the rocker bush has most of the inner lubricant material melted away. All yellow rocker bushes from all cylinder heads should be replaced. Report to Jabiru using Continued Operating Safety Form COSM-1 below.

Figure 3: Badly worn rocker bush.

- Rocker bush wear. May be caused by elevated head, oil or exhaust temperatures or high rpm on cold start up. Troubleshoot as noted above.

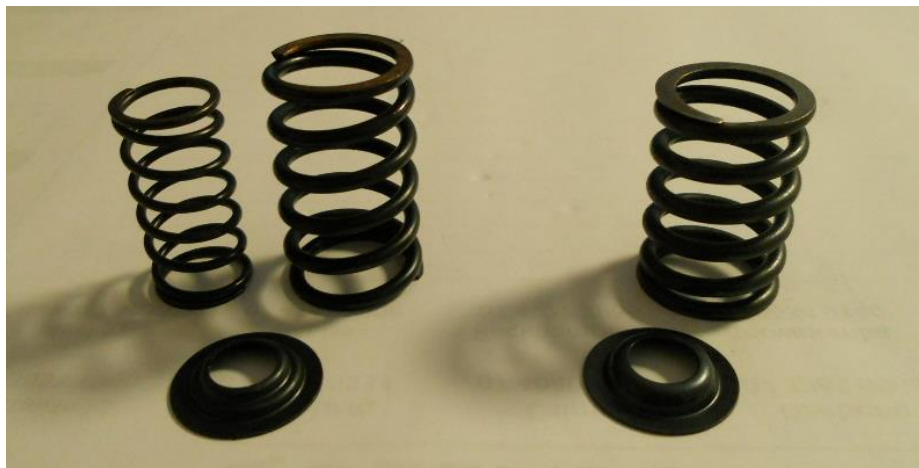
- After substantial design work and testing Jabiru Aircraft has released a configuration upgrade to the valve train. The double valve spring assembly.
- The double valve spring assembly features a small inner spring inside a larger outer spring, the coils are wound in opposite directions to prevent coil binding.

Figure 4 - New double valve spring vs the previous single spring configuration

- The valve seated pressure (i.e. valve closed pressure) is greater than for the single valve spring which can improve valve sealing. This can help prevent problems with compression and valve leakage which may contribute to preventing a valve failure. With a second spring there is now an element of redundancy in the system.
- Double Valve springs can be retrofitted into all Jabiru 2200 and 3300 engines. This upgrade is highly recommended for all engines.
- Upon inspection even if the condition of valves, springs or washers does not necessitate replacement, it is highly recommended that the double valve spring system be installed while cylinder heads are off the engine. In upgrading to double valve springs the following items must be replaced:

- Inner and Outer Valve Springs – replaces the existing single valve spring. **Do not install only the outer spring.**
- Bottom spring washer – The double valve spring assembly requires a specially stepped bottom spring washer with lands for both springs. Double valve springs should not be installed with the existing single spring washer.

- Top spring washer, collets and valves – Similarly the double valve spring assembly requires a special double stepped top spring washer. Since the top spring washer is being replaced the collets and valves themselves must also be replaced with pre-fitted hardware kits. The valves, collets and double land top/bottom spring washers are provided in the double spring inlet and exhaust valve kits.

- When upgrading to double valve springs. The springs (and other items listed above) must be replaced on all cylinder heads (both inlet and exhaust valves) at the same time. **An engine cannot have a mixture of single and double valve springs.**

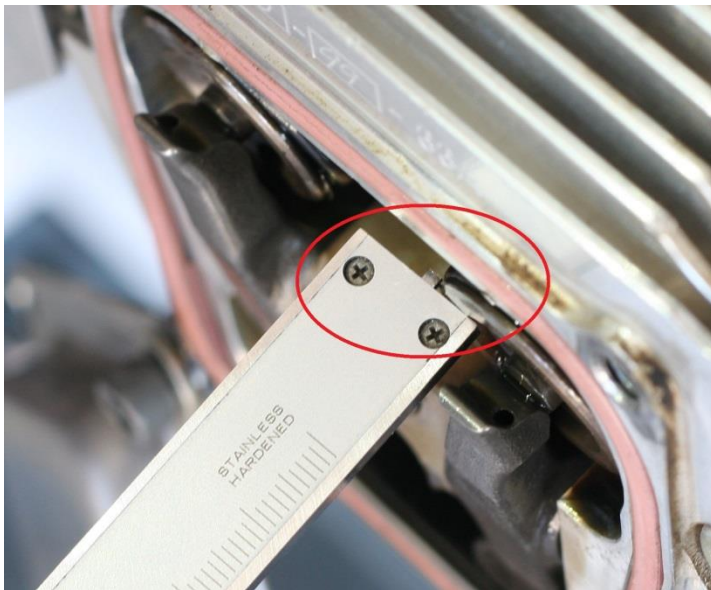
- Remove the rocker covers from all heads (see Head Bolt Tension JEM0002 Jabiru Maintenance Manual).
- Set depth vernier at 1.5mm and compare with the top spring washer and look for any signs indicating wear. If signs are present, proceed with **6.1 Cylinder Head Removal and Inspection**.

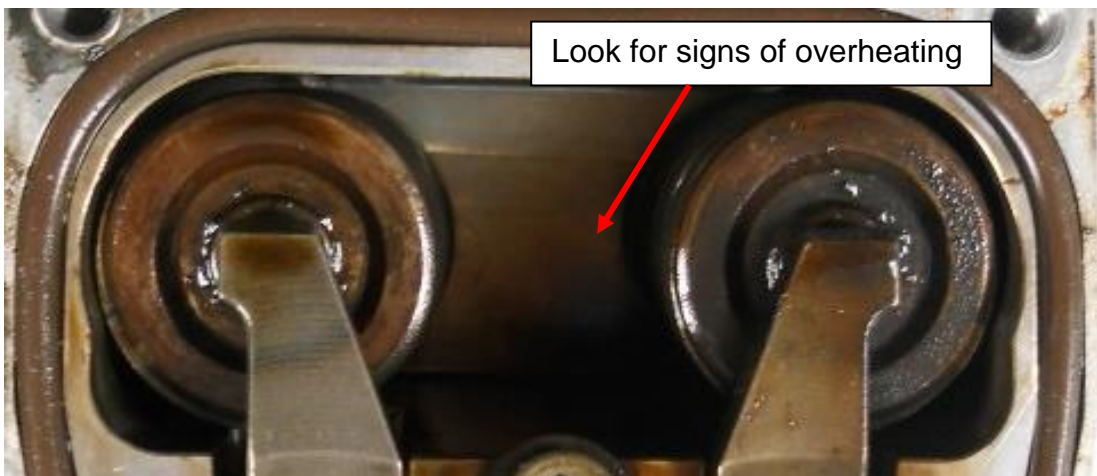
- Look for signs of overheating. If signs are present, proceed with **6.1 Cylinder Head Removal and Inspection**.
