# **Propeller Technical Manual**

C000242-Series Propellers 4A401A0D-Series Propellers C000262-Series Propellers

**DOCUMENT No. JPM3L1-5**

# C000242, C000262, 4A401 Propeller Variants

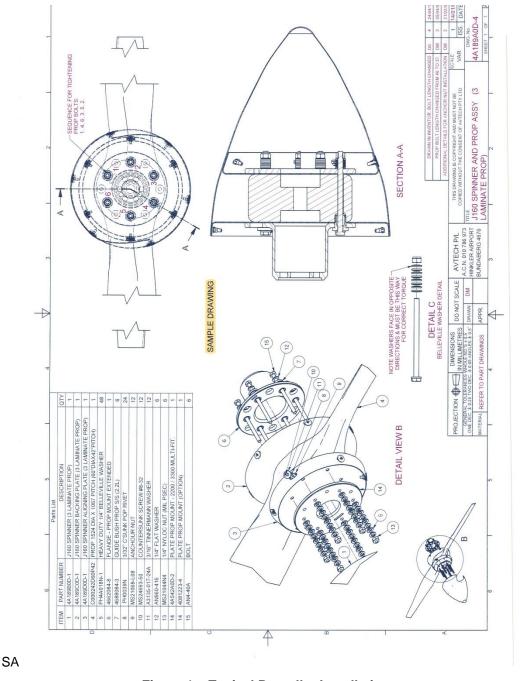
Figure 1 - Typical Propeller Installation

- 7. Progressively tighten bolts ensuring equal distribution of load and in a normal criss-cross torque sequence.
- 8. Using Torque Wrench, tighten Bolts to 6lb.ft (72 inch/lbs).
- 9. Make sure that the nuts haven't bottomed out on the bolt thread.
- 10. Check tracking of Propeller as detailed in Section 5.8.4.
- 11. Locate Spinner on Spinner Flange and fix with Machine Screws through tinnerman Washers.
- 12. Check Spinner tracking as detailed in Section 5.8.5
- 13. Leading edge tape can be applied between the inner edge of the urethane leading edge and the spinner. This optional tape protects the propeller and reduces the chances of moisture ingress.
- 14. After the first flight following the propeller installation the spinner must be removed and the propeller bolts checked for correct tension.

Figure 3 below shows an older propeller hub. Several small cracks are visible extending along the blade from the hub bolts. This type of damage is typically caused by over-torquing the propeller bolts (or not using Belleville washers on the installation as shown in Figure 1).

- Ensure the propeller is installed as detailed in Figure 1.
- Check the fit of the propeller drive bushes in the sockets is not loose.
- Measure the length of the cracks & compare to the limits shown below.

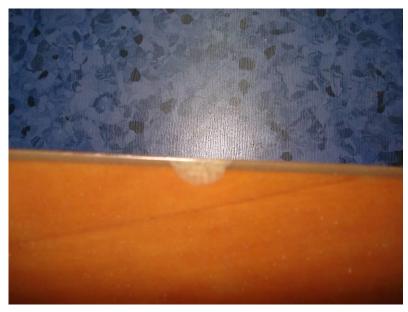
Figure 2 - Trailing Edge Chip

Figure 2 below shows a minor trailing edge chip, approximately 13mm (0.5") long. This type of damage is normally caused in the hangar or while the propeller is in storage or being shipped.

- In general, whitening is a sign that the resin matrix surrounding the fibreglass has been damaged. This type of damage can allow moisture to enter and act as a starting point from which de-laminations can grow.
- If the fibreglass has been chipped or frayed apply a thin type of superglue to the fibres. Capillary action will draw the glue into the glass and the colour will change from white to translucent.
- If the line of the trailing edge has been notched by a small amount (up to 2mm) the notch can be sanded away to leave a smooth trailing edge. This must be done AFTER the glass weave has been stabilised with superglue.
- Maximum size to repair by the method above: 13mm along the blade and extending up to 10mm towards the blade leading edge.
- After repair: visually monitor the chip for growth.

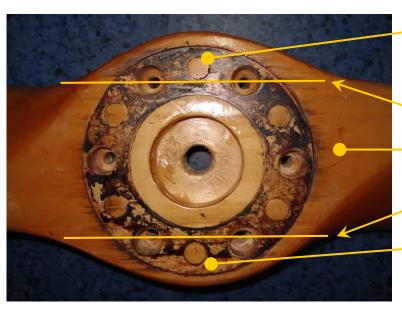
Maximum crack length outside central zone (beyond lines) 50mm (2") or up to the edge of the propeller. If the crack touches the side of the prop it must be visible down the side of the hob for no more than 10mm. (0.39")

Line through centres of outer bolt holes.

Maximum crack length within central zone (between lines) 25mm (1")

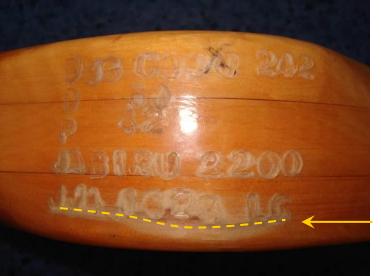
Figure 4 - Hub Compression Cracking

Figure 4 below shows the side of an older propeller hub. A crack running along the grain is visible. This type of damage is typically caused by over-torquing the propeller bolts (or not using Belleville washers on the installation as shown in Figure 1).

Crack

- Check the propeller installation & verify bolt tensions.
- Where the crack has exposed the wood, seal it using a thin type superglue to prevent moisture ingress.
- Overall propeller hub thickness must be greater than 58mm for 3-laminate propellers (shown) or 78mm for 4-laminate propellers.

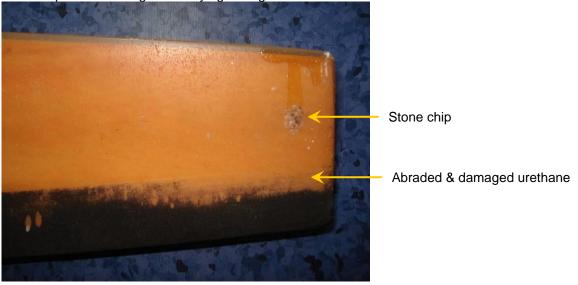
Figure 5 - Stone Chip & Urethane Abrasion

Figure 5 below shows a stone chip and urethane abrasion near the tip of a propeller blade. In this case some superglue has been applied to the stone chip. This sort of damage is generally caused by operations from gravel runways and flying through rain.

- Stone chips like the one shown below are not generally dangerous, however they should be visually monitored during normal daily inspections as it is possible for glass de-laminations to start from them. Using a thin type of superglue to seal the chip is recommended to seal the damage & stabilise the chip.
- The urethane damage shown below is minor. The edge of the fibreglass is not exposed and there are no loose sections of urethane. Note: due to the abrasion of the urethane this propeller tip will be much more susceptible to damage when flying through rain than it would be if the urethane was in as-new condition.

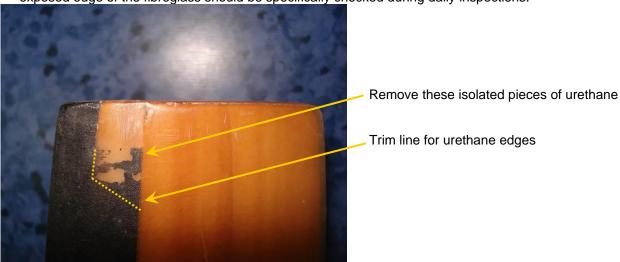
Figure 6 - Urethane Abrasion

Figure 6 below shows more severe damage to the urethane. This type of damage is generally caused by flying through rain or taxiing through long grass.

Urethane loss such as shown below is low-medium level damage. The leading edge of the fibreglass has
been exposed and while the edges of the urethane appear stable they are irregularly shaped and may
begin peeling. A propeller tip in this condition is safe in normal use, however it will be damaged much more
rapidly by rain. The irregular ends of the urethane can be carefully removed with a sharp knife and the
exposed edge of the fibreglass should be specifically checked during daily inspections.

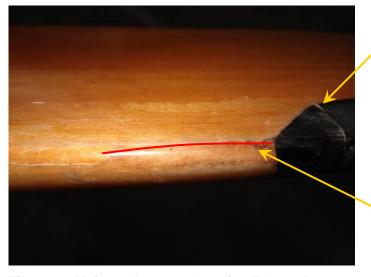
Figure 8 – Moisture Ingress – Leading Edge at Root.

Figure 8 below shows cracking in the resin shell of the propeller at the leading edge between the inboard end of the urethane and the start of the spinner. The example shown is also fitted with leading edge prop tape. This damage is usually caused by moisture ingress into the blade causing the wood to swell and crack the resin coating. The moisture can enter whenever the blade is exposed to water: flying through rain, covered by dew overnight etc.

Prop tape runs from the inboard end of the urethane through to the spinner.

Cracking visible in the resin at the leading edge

- The damage shown below is a minor example of its type. At this stage it should be covered with prop tape and monitored.
- If the cracking progresses any open cracks should be sealed with a thin type of superglue. Maintaining a seal over the wood is the best way to prevent this type of damage from spreading.

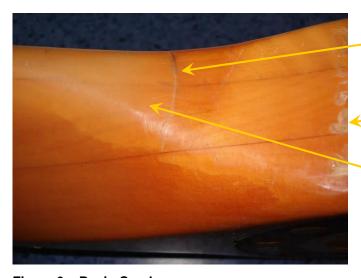
Figure 9 – Resin Crack

Figure 9 below shows cracking in the resin shell of the propeller near the hub. Cracks of this type can occur in older propellers in areas where there is only resin (and no fibreglass) covering the wood.

Crack. Note black mark near the top where moisture has entered through the crack & stained the wood.

Edge of hub markings visible

- The inner end of the fibreglass can be seen as the colour of the composite covering the wood changes from a relatively opaque covering to a clearer coating. Fibreglass/resin composite is more opaque than resin alone. The fibreglass coverings of the propellers covered by this manual run from the tip of the blade to a point approximately 100mm (4") from the centre of the propeller.
- Cracks such as this one are not a structural issue provided that they are no more than 110mm from the prop centre and are no longer than 50mm (2").
- Where a crack has opened slightly it must be sealed with superglue to prevent moisture entering. The black marking of the upper part of the crack shown below is due to moisture staining the wood.

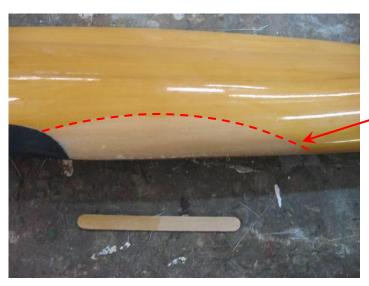
Figure 10 - Fibreglass De-lamination

Figure 10 and Figure 11 below show an extreme example of the same type of damage shown in Figure 8. In this case the initial minor cracking was not sealed. Over a period of several months more water entered and a small de-lamination began; the aircraft continued to be flown. The result is that the fiberglass has delaminated from the wood over a large area.

Edge of delaminated area

- IT IS NOT SAFE TO FLY WITH ANY AMOUNT OF DE-LAMINATION. Whenever de-lamination is found the propeller must be removed from service and repaired.
- It is unusual for a de-lamination to reach this size. Normally air pressure acting on a smaller de-lamination would rip the fibreglass off the entire blade. Happening in flight this leads to an extremely out of balance propeller normally the engine must be shut down immediately and an emergency landing carried out.

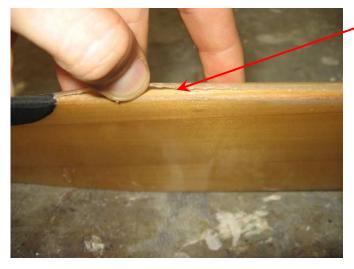
Fibreglass no longer bonded to wood.

Wood exposed at leading edge.

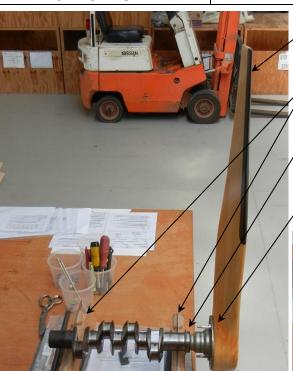
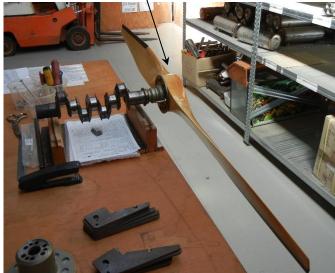
Figure 12 - Propeller Balancing

Propeller balancing vertically

Balance jig – steel rulers mounted level.

Propeller mounted to prop flange using 2 propeller drive bushes & bolts

Propeller balancing horizontally

- The "knife edge" balance blades are horizontal
  - There are no bends, dents, nicks or damage to the "knife edges" or the balance shaft which may prevent the assembly from rotating.
